Mill Case Study – A Contractor Incident

Contractor fatal fall

October 17, 2011

Engineered Lumber Mill

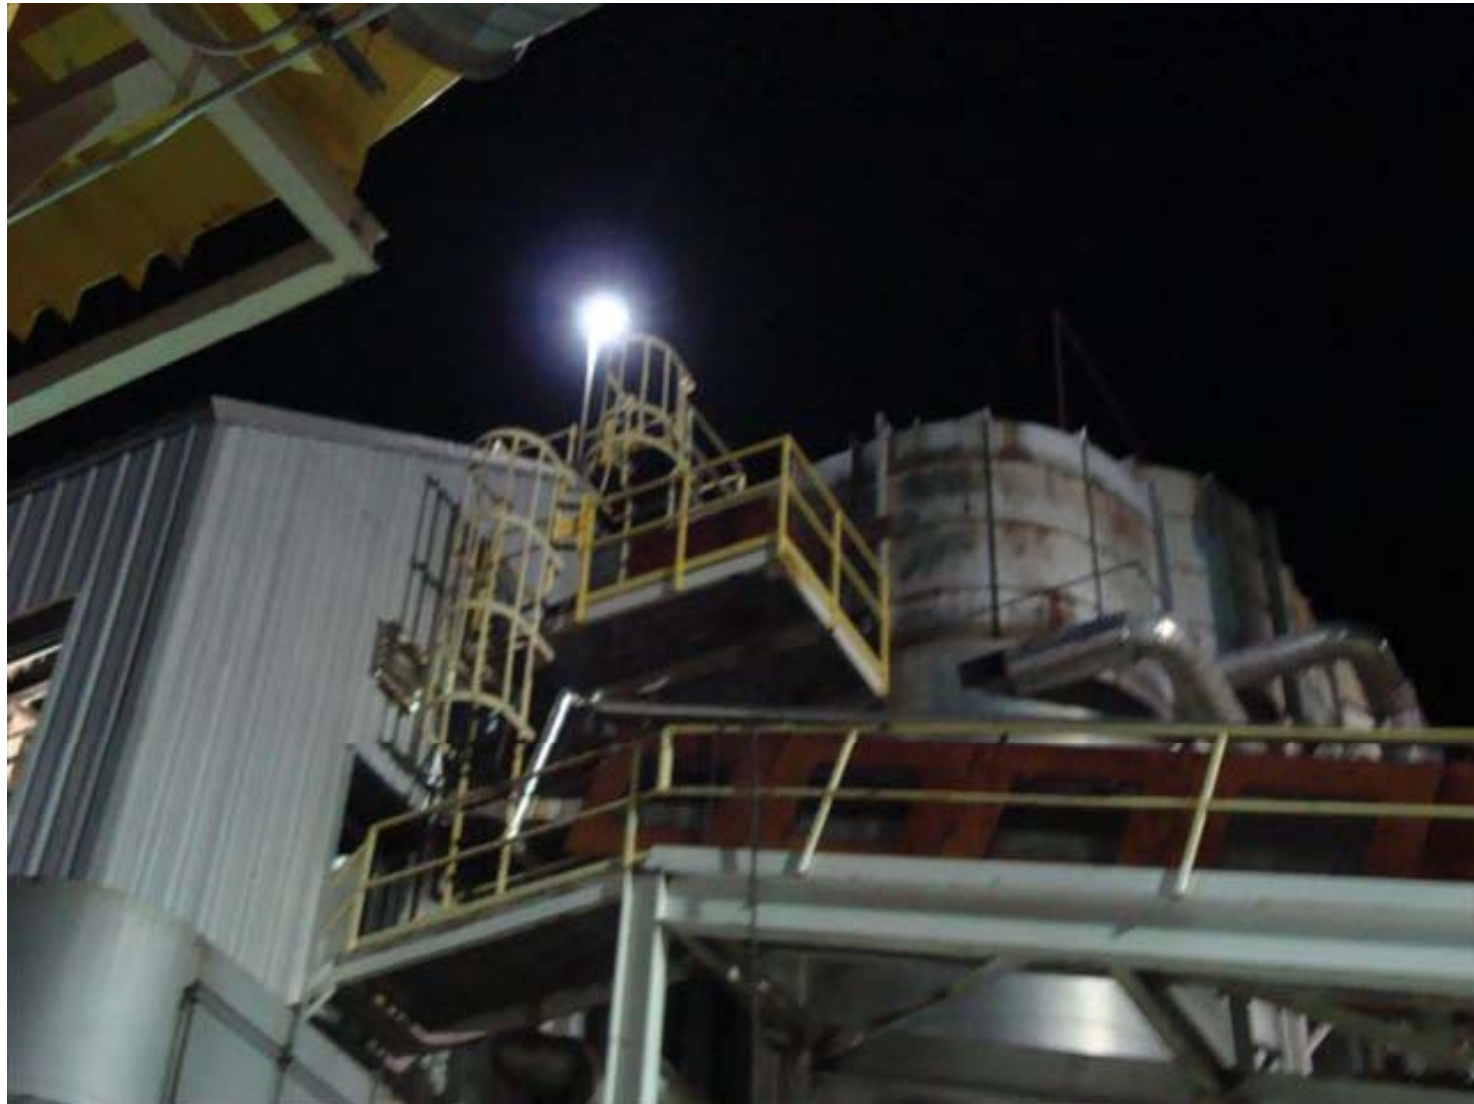
Heat Energy Area – Night of Incident

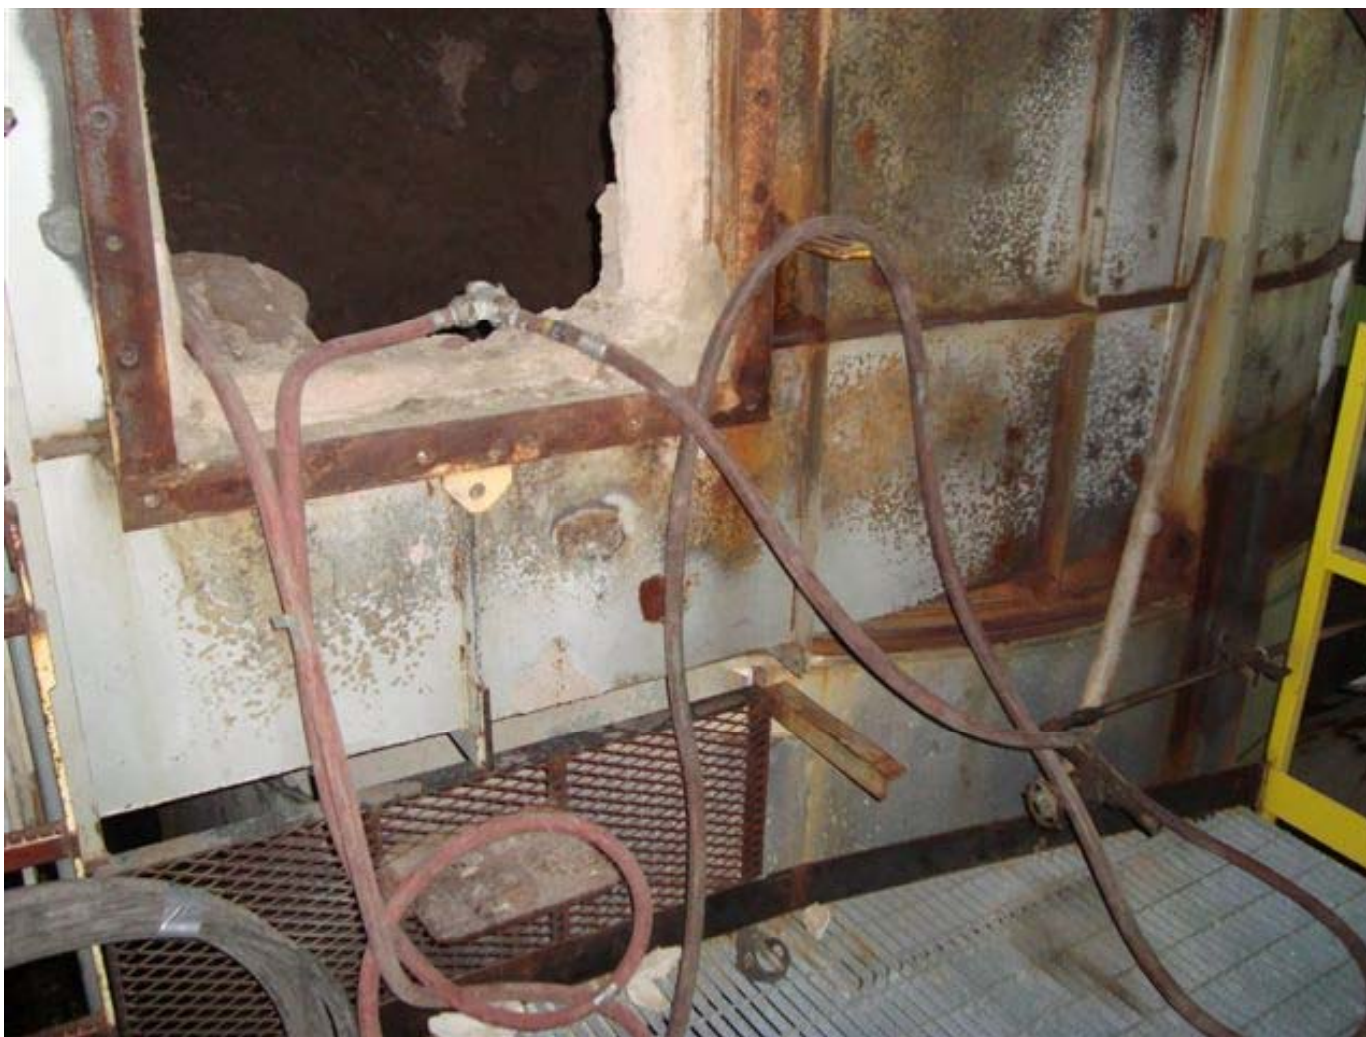
Transition Duct Hatch, Step and Staged Air Hose

- **The distance from the platform deck to the lower ledge of hatch is about 39 inches meaning no guard (such as a railing) is required by OSHA regulation. The steel step formerly welded to outside of the Transition Duct was about 13 inches above the platform. The distance from the step to the lower ledge of the hatch was about 26 inches. No guard was in place at the time of the incident. The facility removed the step after the incident.**

- **Remove the step that was welded to Transition Duct. (This was done immediately.)**
- **Determine whether additional controls (e.g., an internal guard or railing) are needed to mitigate the fall hazard created if steps are required to access the hatch.**
- **Update the facility's written confined space program to:**
 - **Transfer responsibility from one permit entry supervisor to another as required**
 - **Verify the availability of the emergency rescue crews prior to issuing a confined space entry permit**
 - **Use reasonable measures to prevent unauthorized entry into a confined space.**

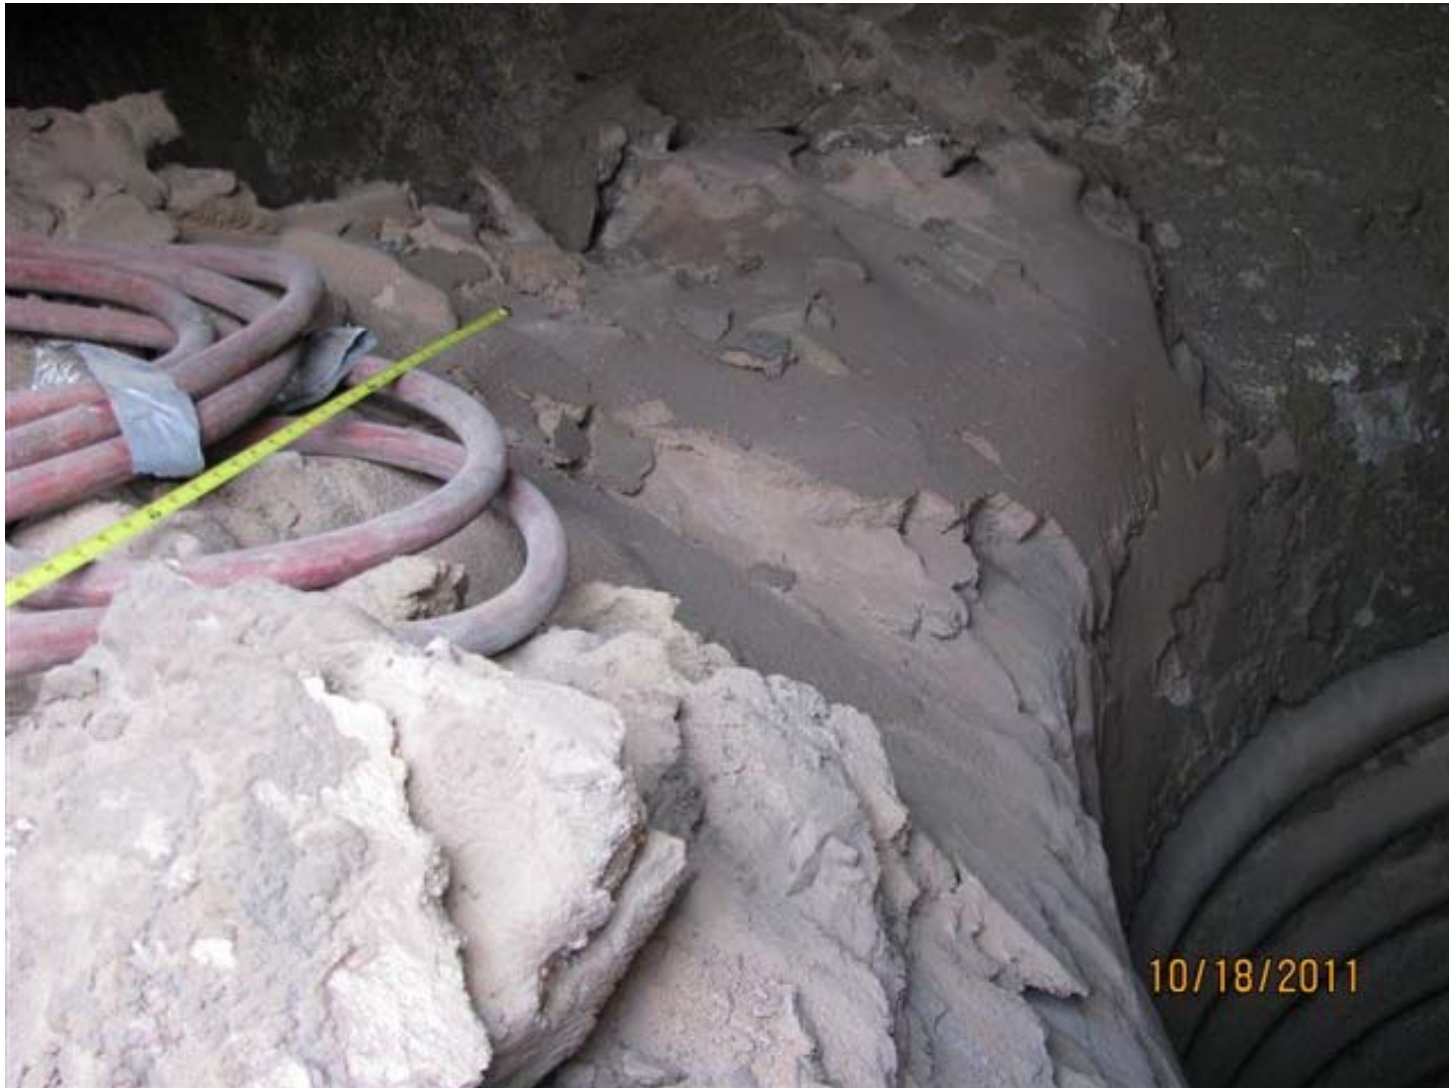
Interior of Transition Duct Viewed Through Hatch

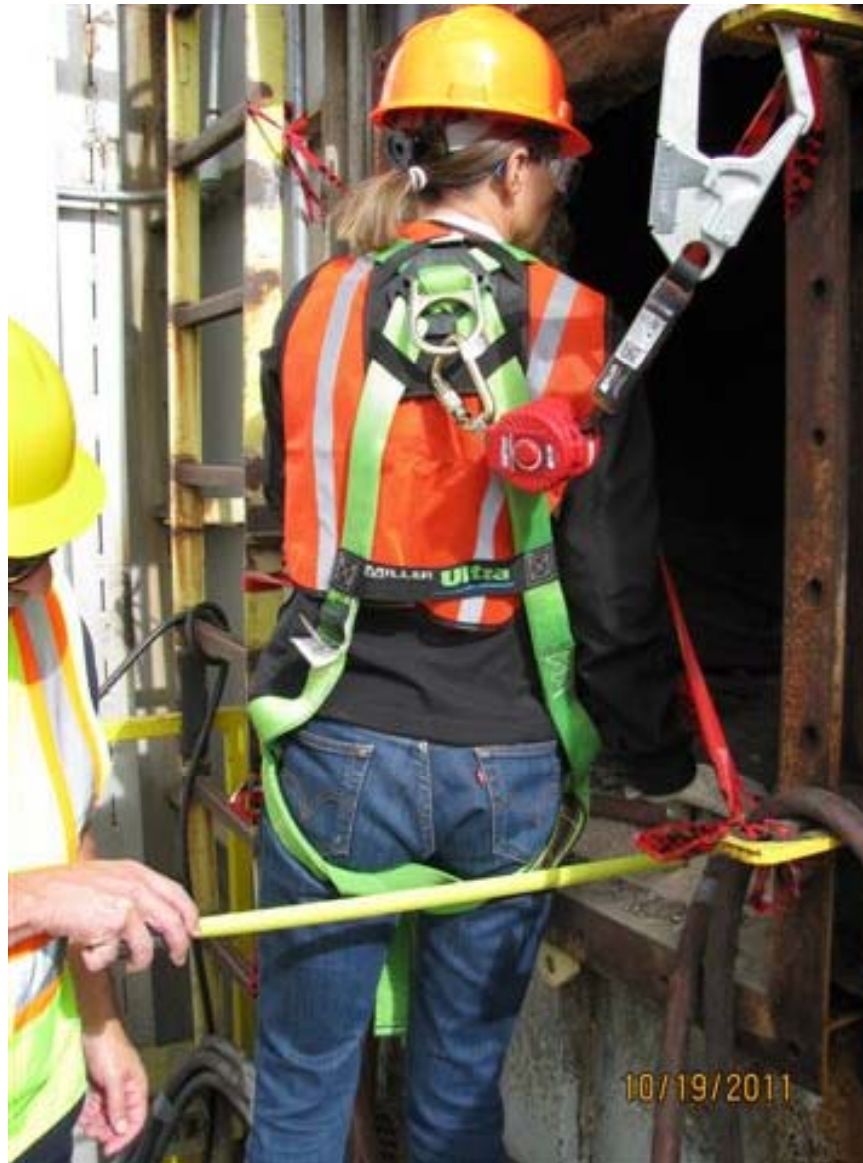
Position Standing on Step Below Hatch
