Port Wentworth Fatality Review

Robbie Linton Fatality

Port Wentworth Cellulose Fibers Mill

Vehicle/Pedestrian Collision

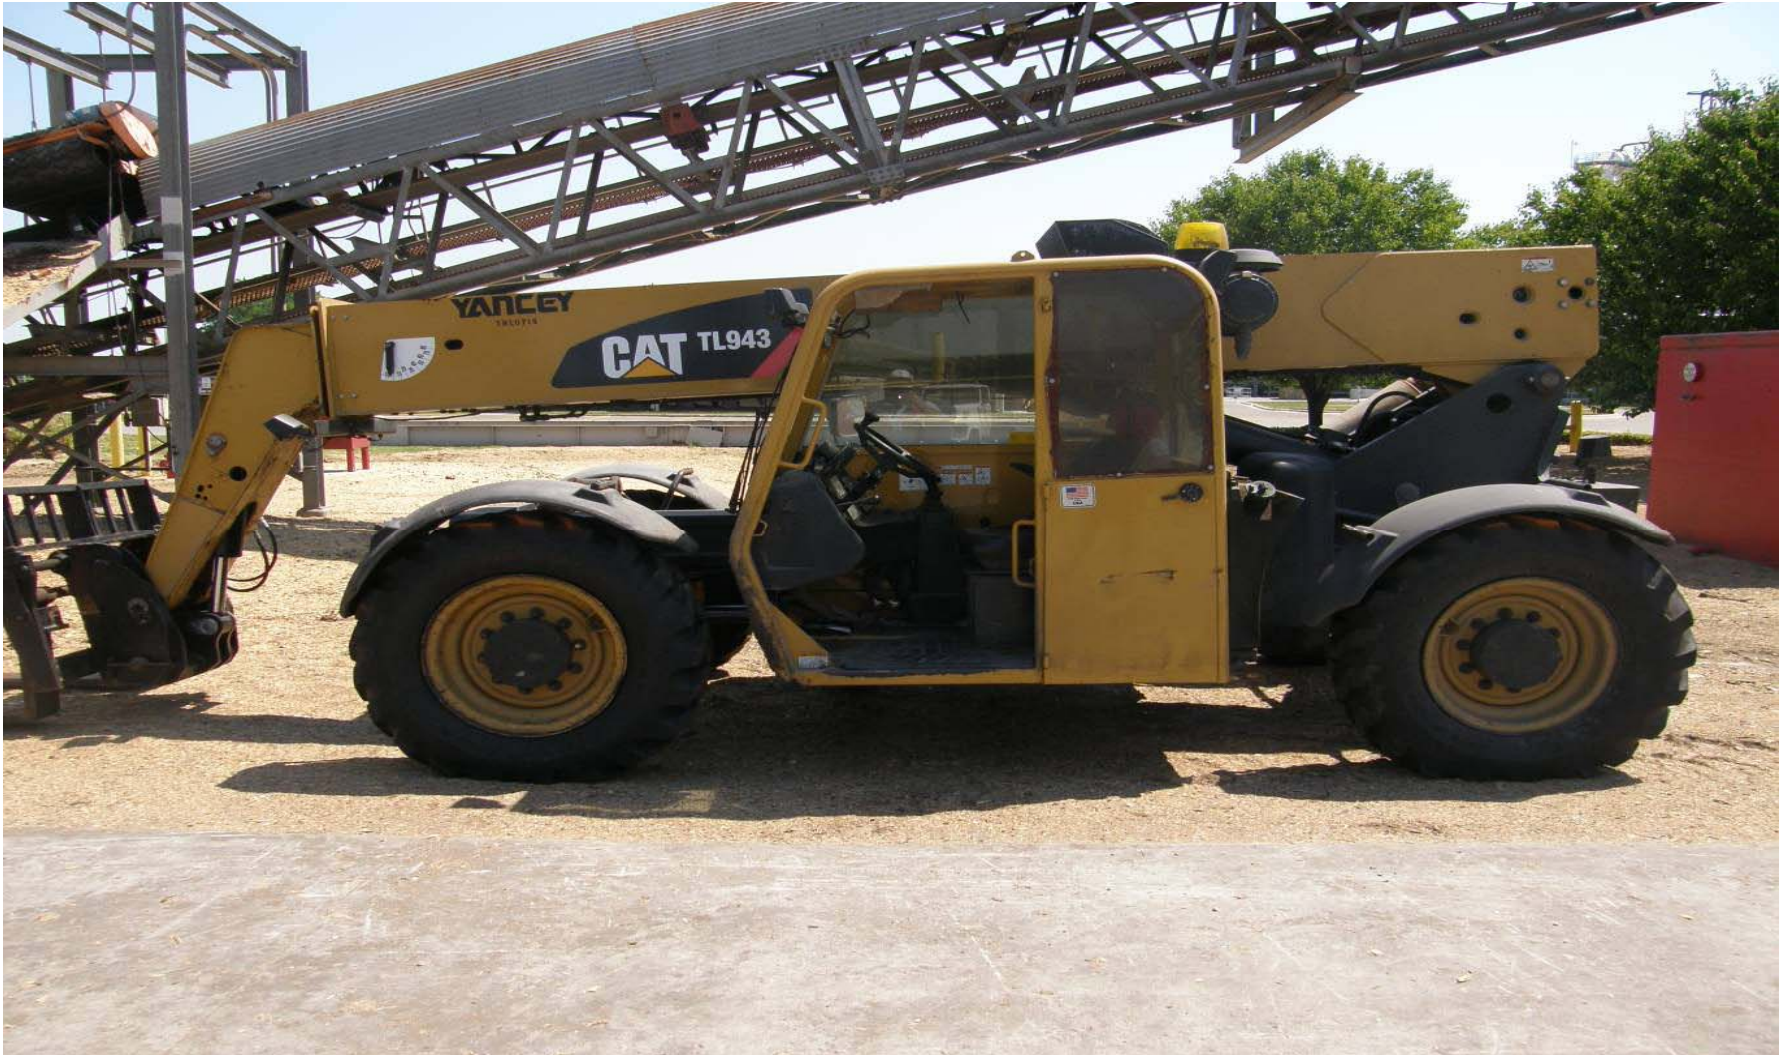
CAT TL943 Telehandler

- **All telehandler operators are trained and certified.**
- **Visibility on the right side of the lift is almost entirely obscured by the boom when it is in the lowered position. Visibility to the front is partially obscured by the forward end of the boom and the loaded bin.**
- **Re-enactments indicate the telehandler operator would not have seen Robbie crossing over into the vehicle's path unless specifically bending down and looking under the telehandler boom. Also that Robbie would have been in the area of restricted vision from the time he left the sidewalk until the point of impact**
- **Noise level of the telehandler in comparison to mill ambient noise was insufficient to have attracted Robbie's attention away from his focus on intervening with the log truck.**
- **The telehandler was moving very slowly (below the 10 mph posted speed limit) at the time of the incident.**

- **The Telehandler operator has a significant area of restricted vision on the right side when operating the vehicle in accordance with manufacturer's instructions and mill practices.**
- **The screen reject material protruded above the top of the waste bin restricting the driver's forward vision. In addition his attention was drawn to the left towards the log truck and the protruding log.**
- **The log protruding from the outbound log truck created a high potential unsafe condition for pedestrians and other equipment.**

- **Design of this model of telehandler has resulted in a field of restricted vision on the right side due to boom placement when carrying a load with the forks lowered.**
- **The risk of operating the telehandler in pedestrian and mobile equipment traffic areas, with its field of restricted vision was recognized by mill personnel but felt to be managed adequately by on-the-job training and hands-on instruction. There have been no incidents regarding visibility formally reported.**
- **There is a written safe operating procedure for the telehandler, however, it does not address the level of screen reject material allowed in the bin for safe transportation nor does it address the visibility restrictions.**

- **Tag out and review the use of the Telehandler involved in this incident to determine the applications and areas for safe operation at the mill – Complete, the equipment was immediately tagged out of service and will be removed from Site.**

- **Include in written operating procedures direction on the level of screen reject material allowed in the bin for safe transportation and controls to mitigate or eliminate the visibility restrictions when operating in areas of pedestrian and other vehicle traffic – Complete**

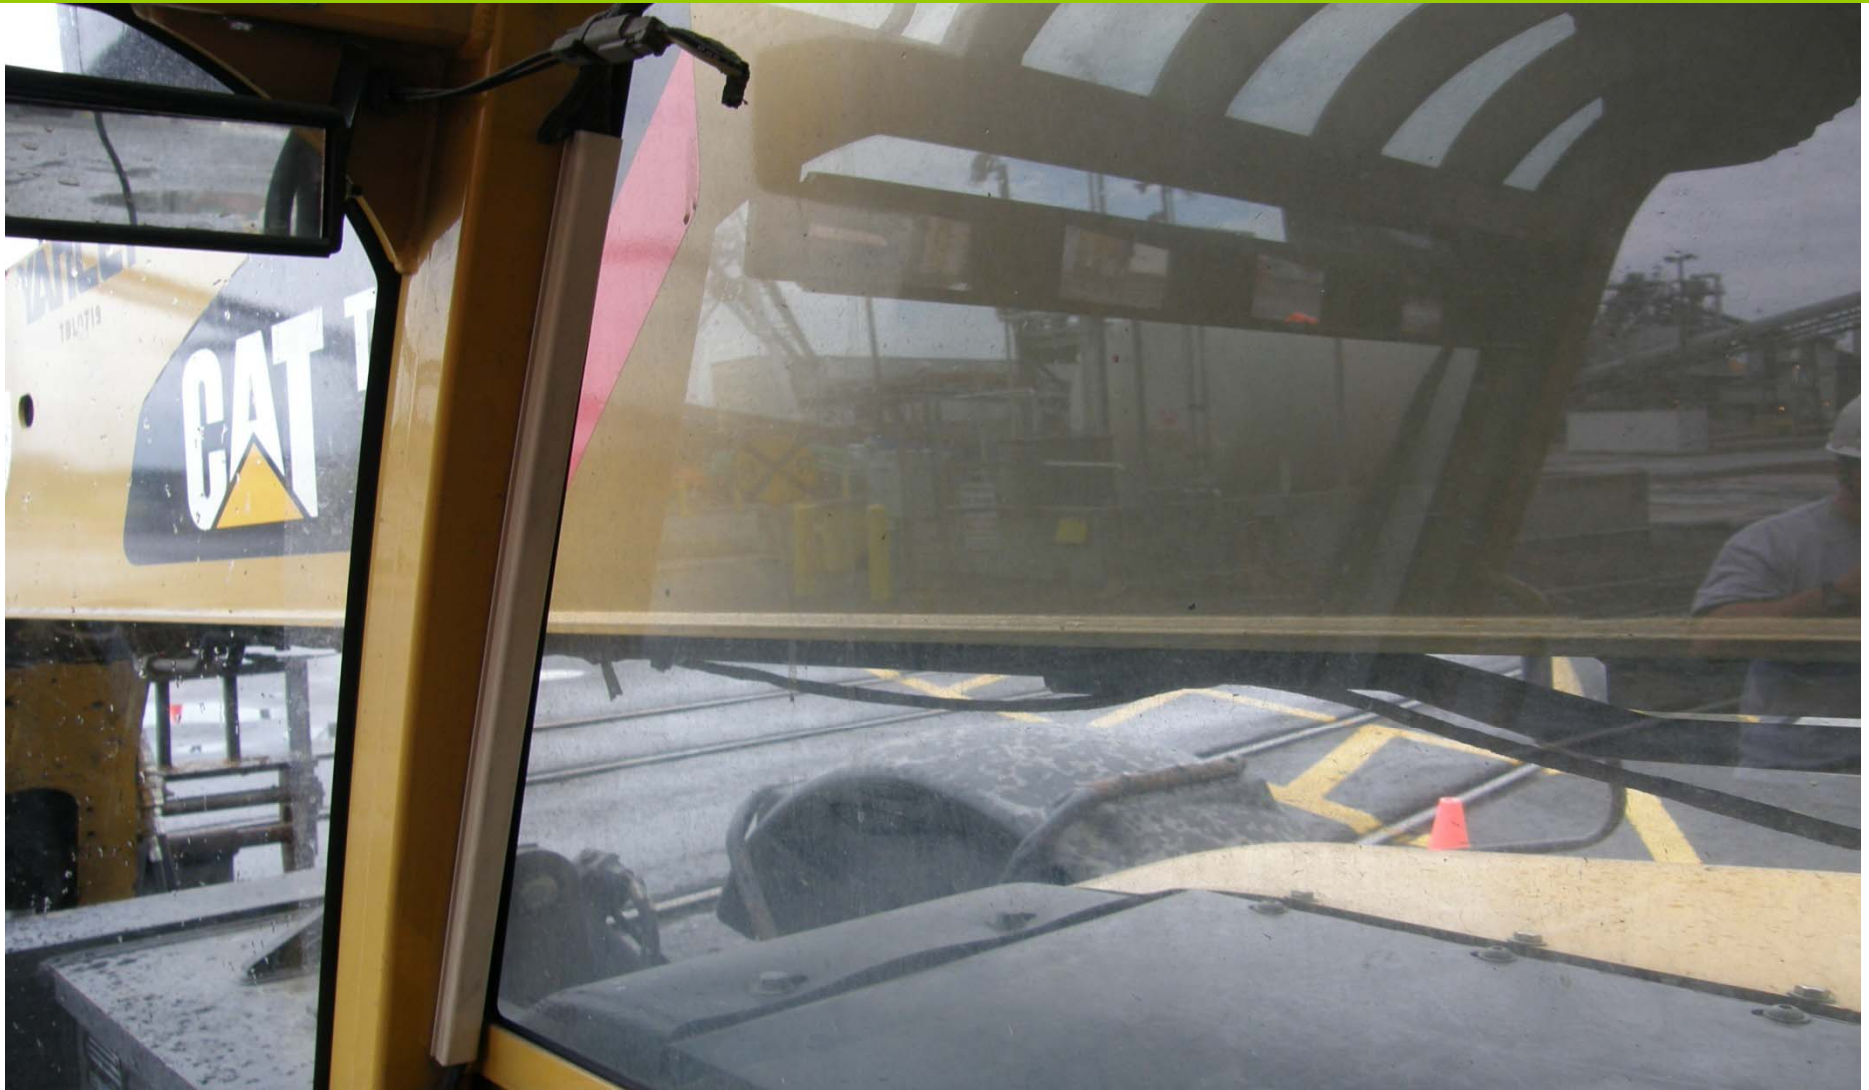
Restricted view from inside cab with boom lowered

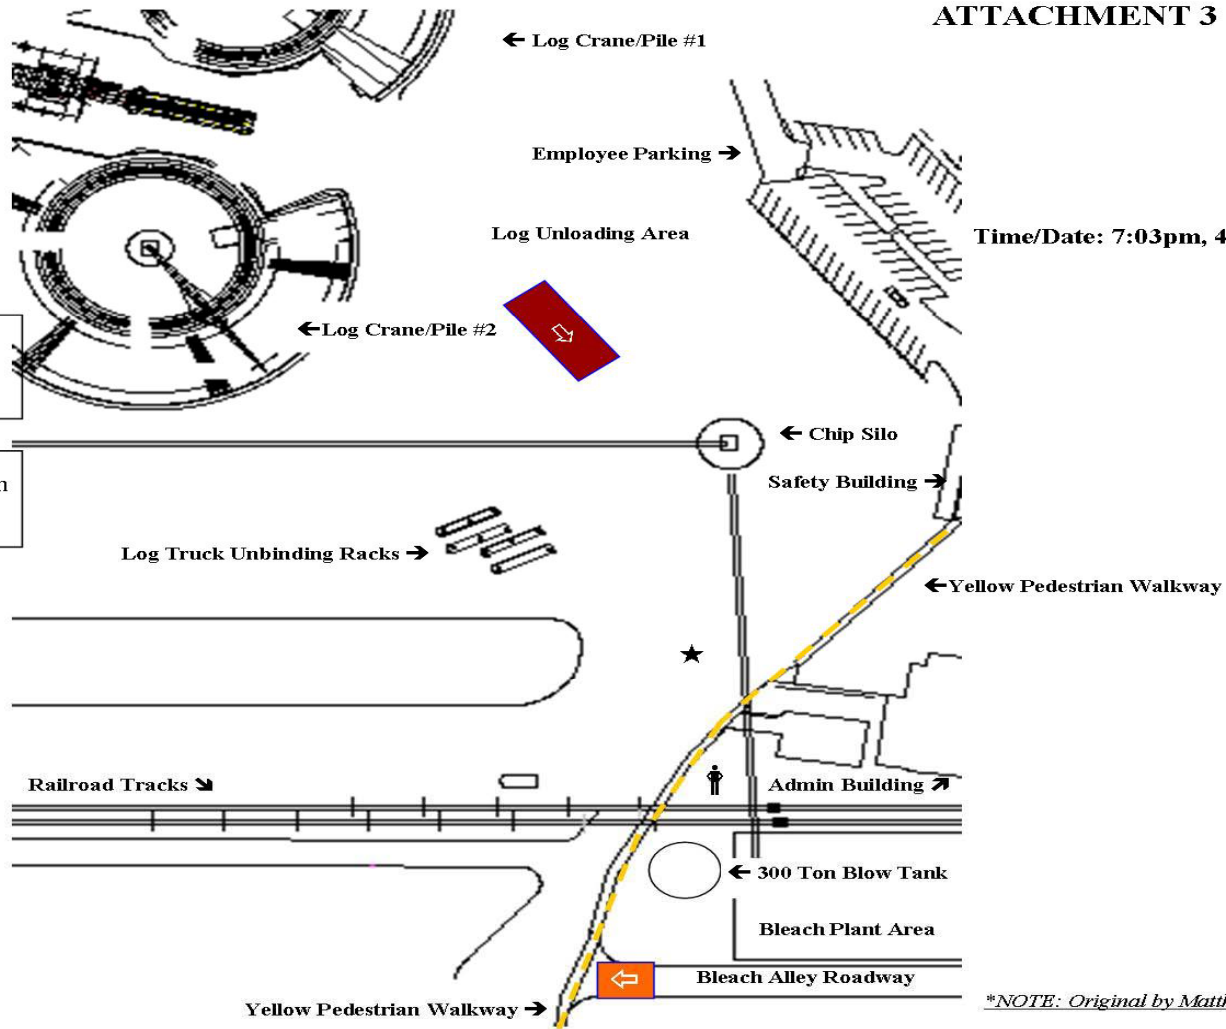
Schematic of incident Scene Timing

Telehandler
 Direction is West
 Driven by Joey Gay

Log Truck
 Direction is South East
 Driven by Henry Pelote

Pedestrian
 Direction is North East
 Walking is Robbie Linton

Point of Impact at 7:04pm

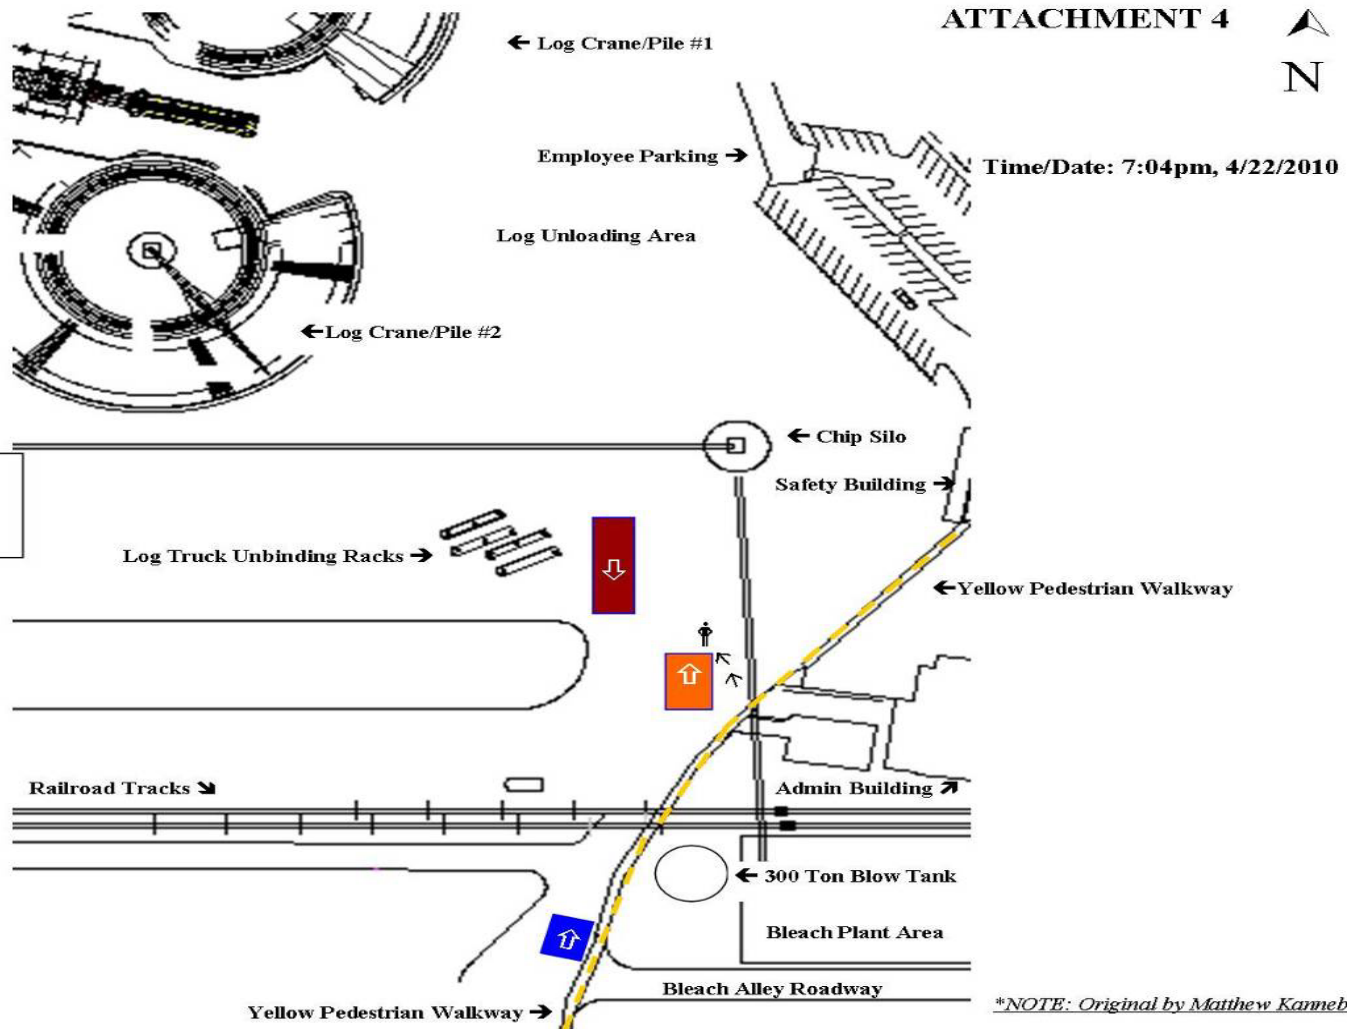
Schematic of incident Scene Timing

Security Golf Cart
Direction is North
Driven by Wes Oglesby

Telehandler
Direction is North
Driven by Joey Gay

Log Truck
Direction is South
Driven by Henry Pelote

Pedestrian
Direction is North West
Walking is Robbie Linton
