# Safety Communication

## Near Miss Details:

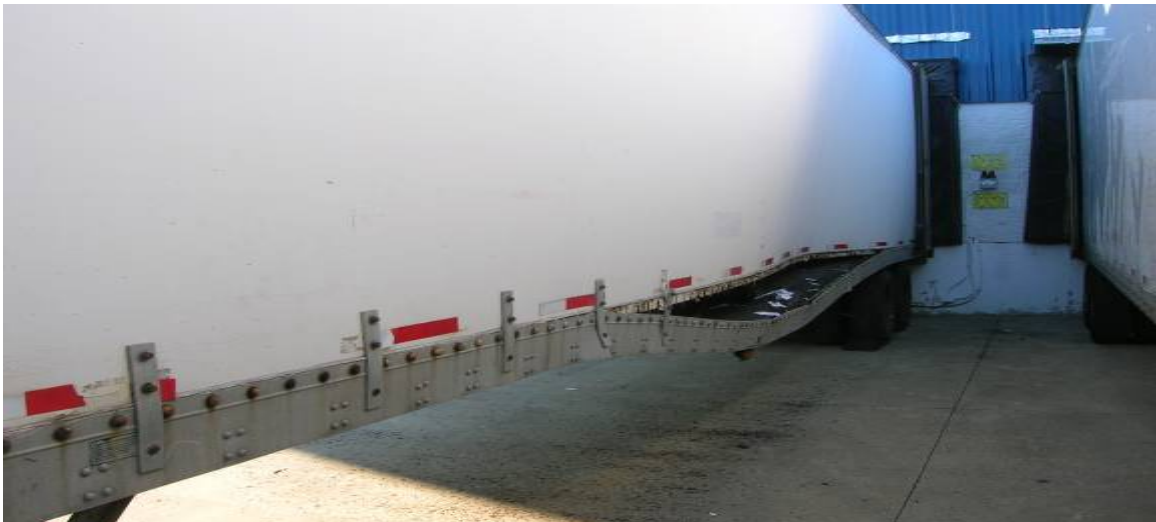
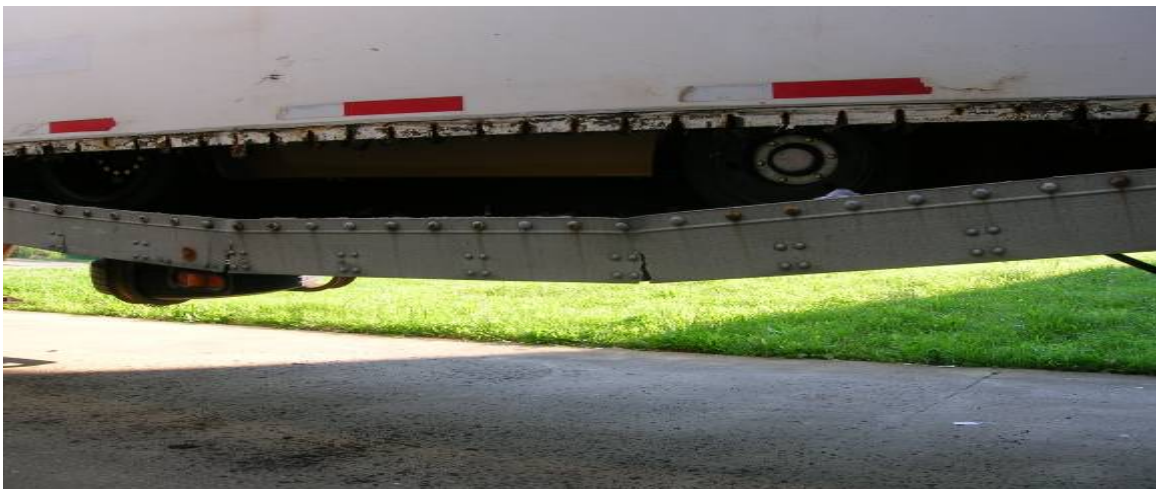
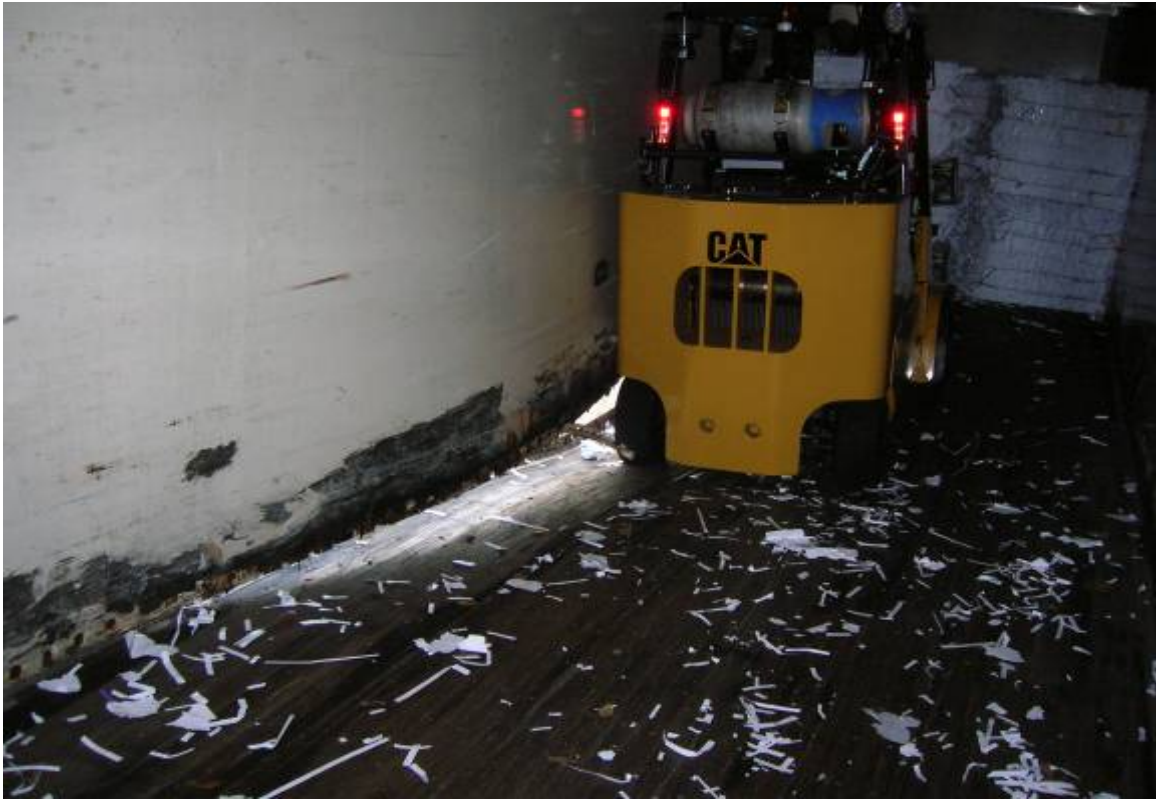
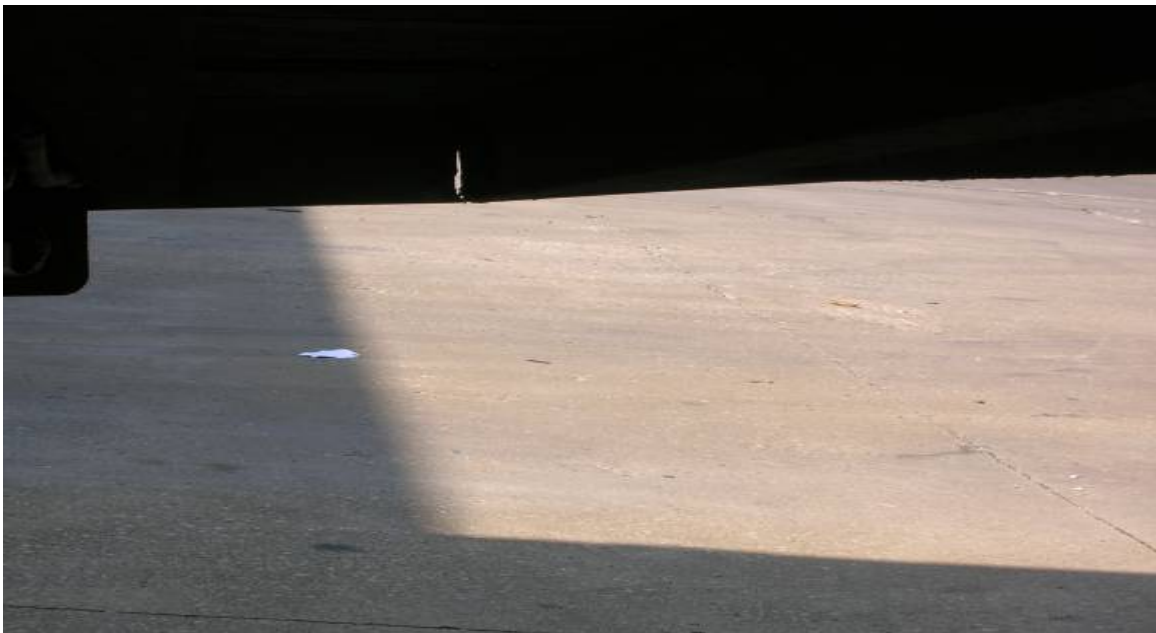
An operator was loading a trailer with bales using a clamp truck. The operator had loaded 18 bales onto the trailer when the left side of the trailer unzipped allowing the floor to separate from the wall. The basic cause of this incident was the failure of the structural integrity of the trailer. The immediate cause was improper maintenance and repairs of the trailer by the trucking company. An inspection of the trailer was performed prior to the loading of this trailer. However, our investigation discovered that our operators did not fully understand some of the terminology on the form and did not know exactly what to look for while performing the trailer inspection.

Our inspection form will be revised. The form will contain pictures which will show the location on the trailer and describe exactly what to look for. A trailer inspection safety video will be added to our dock safety training. All operators will view the video before they start working on our docks. This video will also be used as one of our monthly plantwide safety trainings. A communication board will be posted in the dock locations. This board will have trailer loading rules posted on it as well as a section to post pictures, memos, and notices.
