PEDESTRIAN GUARDING

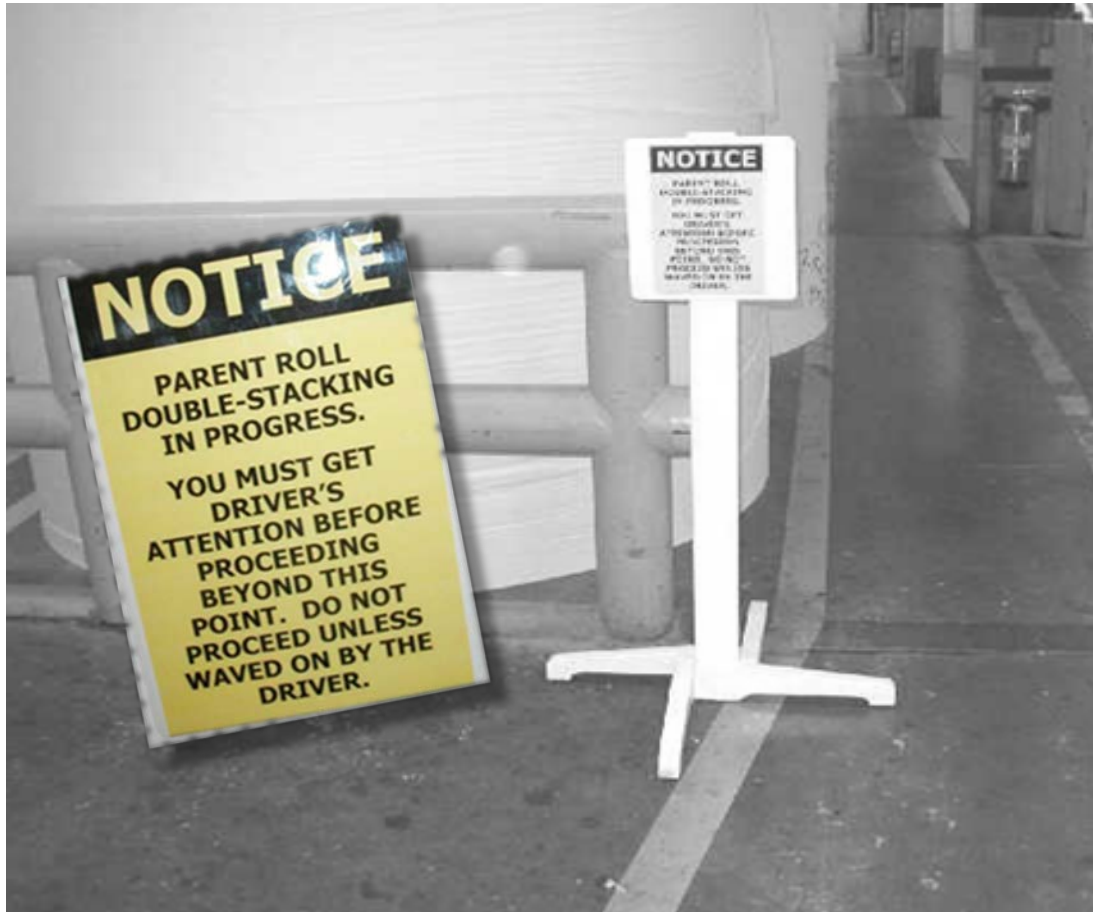
Pedestrians walking through parent roll storage are exposed to the possibility of parent rolls being toppled on them. Administrative controls proved ineffective and would breakdown easily leaving pedestrians vulnerable to this hazard. Clamp truck drivers would forget to place "notice" signs in pathway, hand signals were misunderstood, and signs were left out with no roll movement happening.

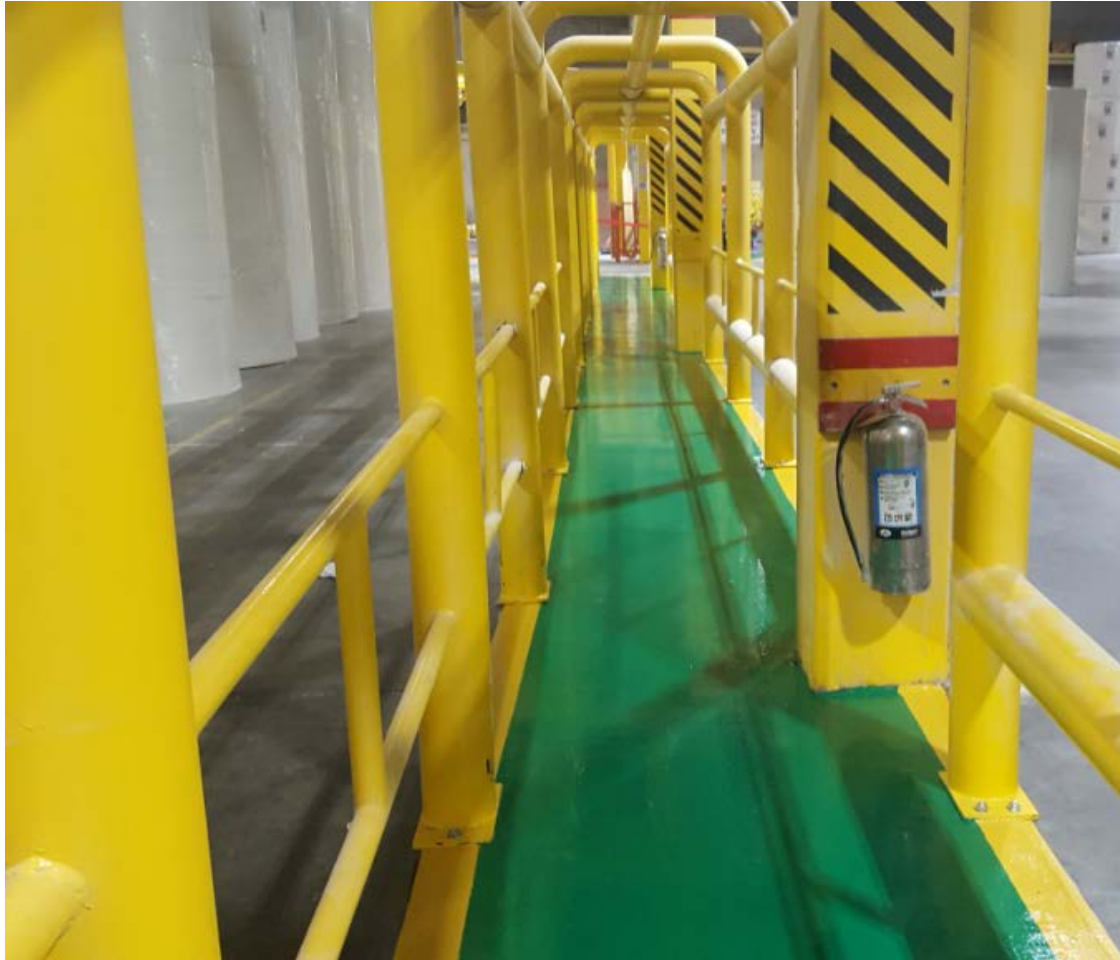
AFTER

- Eliminated the practice of using unreliable administrative controls for pedestrian safety.
- Eliminated the risk of a catastrophic stuck-by incident while walking through parent roll storage.

- Installed 100ft protective steel enclosure through parent roll storage.
 - Following the facility marking plan, applied green and yellow pathway through parent roll storage.
 - Highlighted pedestrian intersection with green and white standardized markings.
