Mill Case Study – A Contractor Incident

Contractor fatal fall

October 17, 2011

Engineered Lumber Mill

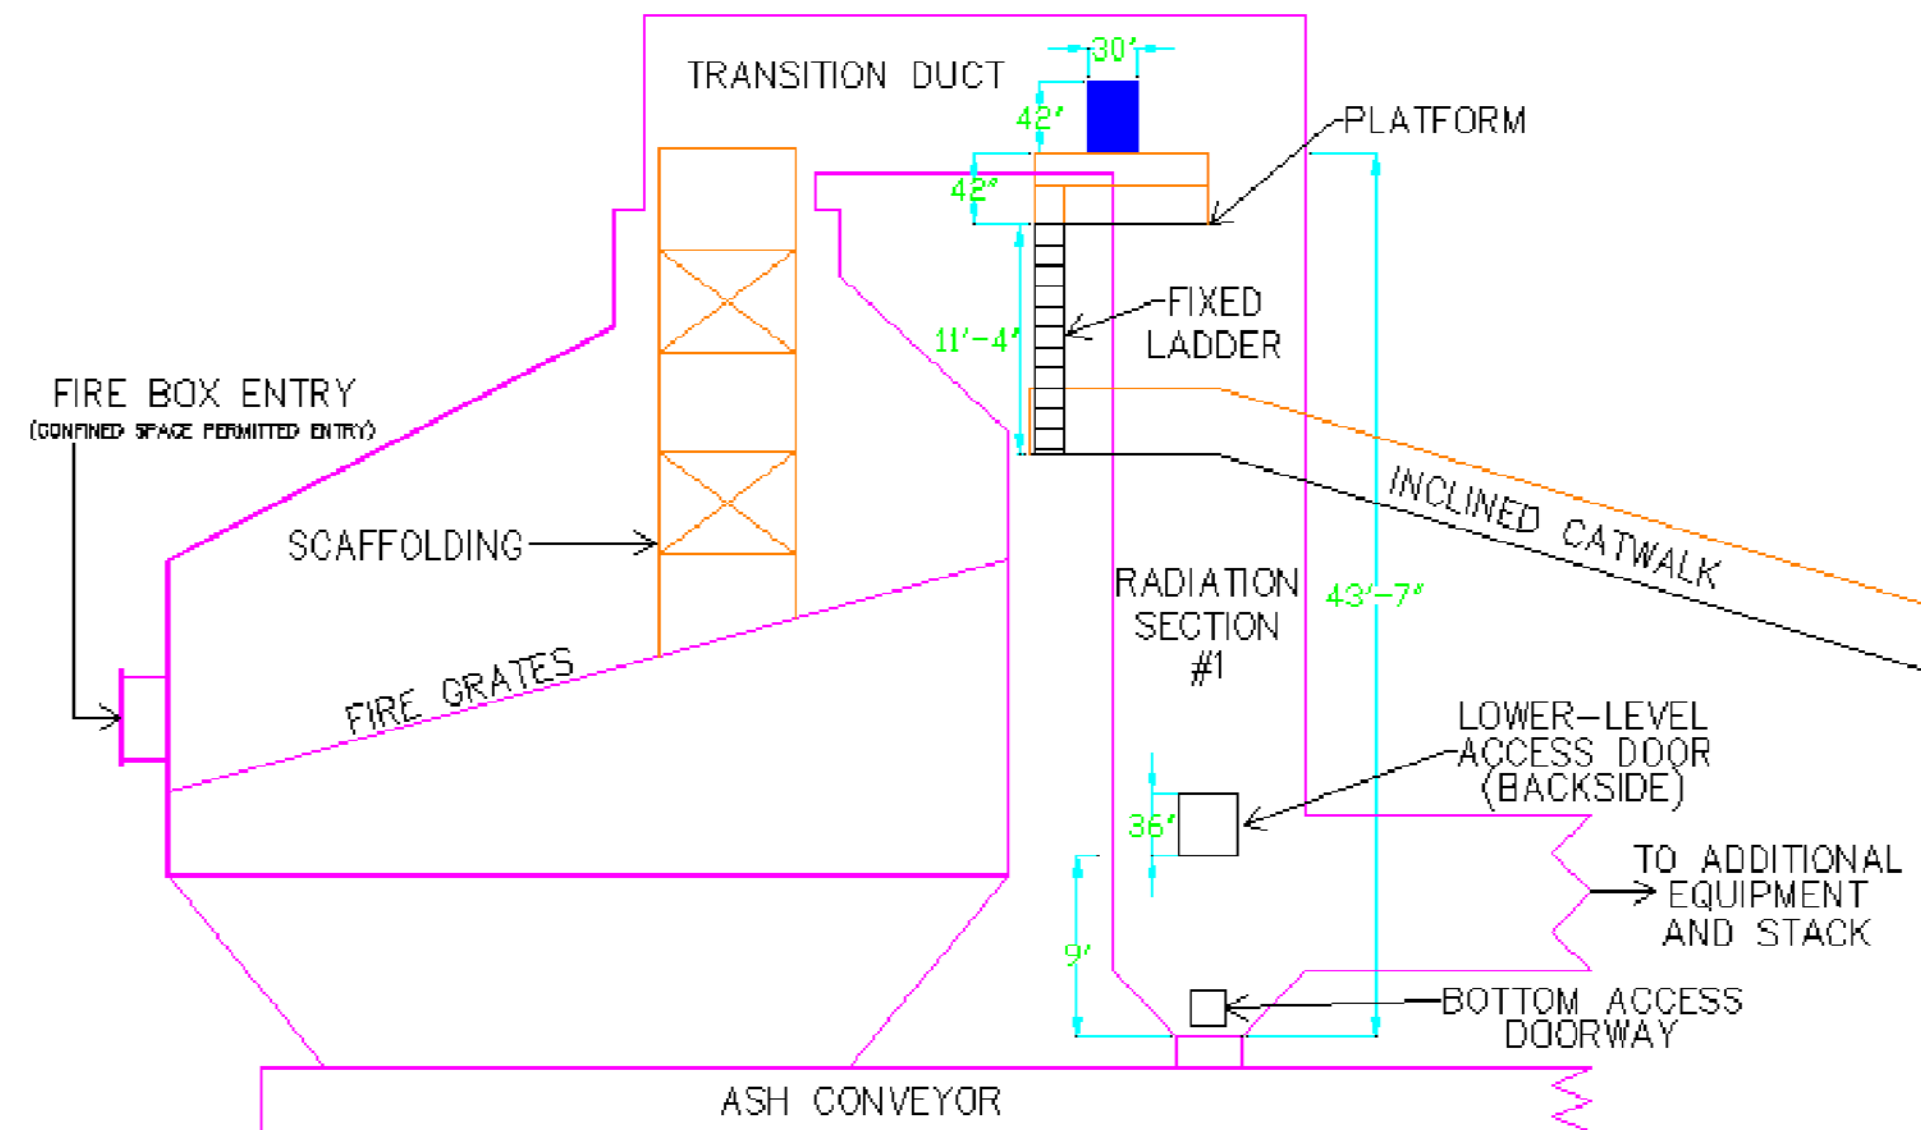
DIAGRAM 1

- **The Contractor was found in the cone-shaped base of the No. 1 heat exchange vessel covered with ash. He had fallen about 45 feet and suffered severe injuries.**

- **The Contractor's workers had received training in confined space entry.**
- **The Contractor did not identify the hatch in the Transition Duct as an entry point or request an entry permit for the hatch. The facility did not issue a confined space permit allowing entry through the hatch.**
- **A review of the incident scene showed that the plane of the hatch had been broken prior to or during the incident.**
 - **Footprints were observed on a steel step welded to outside of the Transition Duct.**
 - **What appeared to be a handprint was found immediately inside the hatch on the slag build up next to a portion of the slag that had broken away.**
 - **One coil of air hose was found inside the hatch on the left hand side. This coil was placed inside the hatch by one of the contractor's workers.**
- **No one saw the contractor fall.**

- **Remove the step that was welded to Transition Duct. (This was done immediately.)**
- **Determine whether additional controls (e.g., an internal guard or railing) are needed to mitigate the fall hazard created if steps are required to access the hatch.**
- **Update the facility's written confined space program to:**
 - **Transfer responsibility from one permit entry supervisor to another as required**
 - **Verify the availability of the emergency rescue crews prior to issuing a confined space entry permit**
 - **Use reasonable measures to prevent unauthorized entry into a confined space.**
